Mitigation of Corrosion in 5xxx Series Al-Mg Alloys in Marine Environments: Grain Boundary Engineering and Cold Spray Coating Approaches

Date: March 26th, 2014

ONR Award #: N00014-11-1-0326 (01/01/2011-12/31/2013)

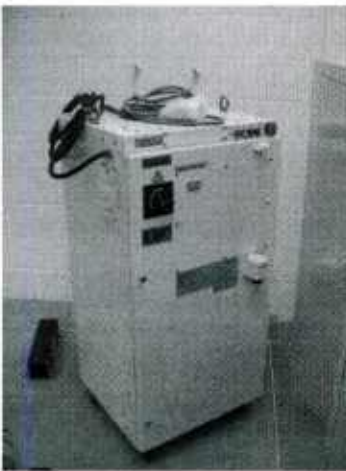
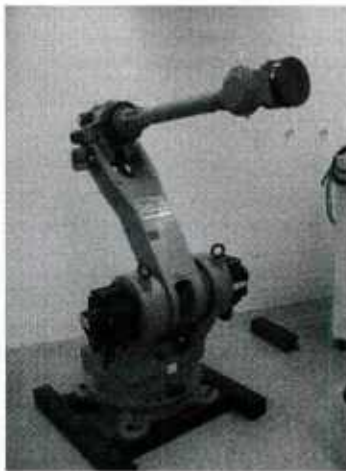
Figure 30. The robot controller (a) and 6-axis robotic arm allow manipulation of the cold spray gun for deposition on most geometries.

In order to manipulate the 20kg cold spray gun a robotic arm needed to be procured. The researchers decided to purchase a gently used 6-axis Nachi SC50F-01 (shown in Fig. 30 (a) and (b)) which has the capacity to hold up to 50 kg from the end of the robotic arm. A showroom unit with only 175 hours on it (very low for a production scale robot) was purchased from Antenen Research of Cincinnati, OH. The ability to manipulate the arm around 6-axis allows complex geometries to be sprayed, and can allow the manipulation of the robot-mounted spray gun to reach tight spaces, an important consideration especially when used in a small research grade spray booth.

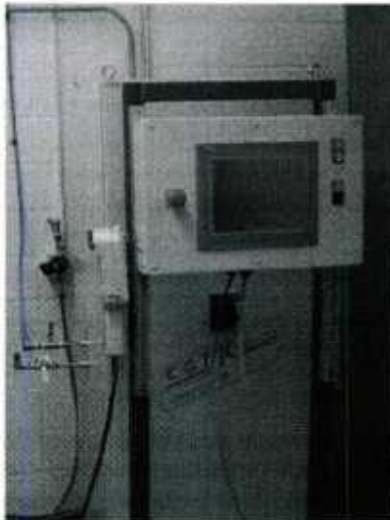
Figure 34. *The control console for the CGT Kinetiks cold spray system complete with easy-to-use user interface via the touch screen panel.*

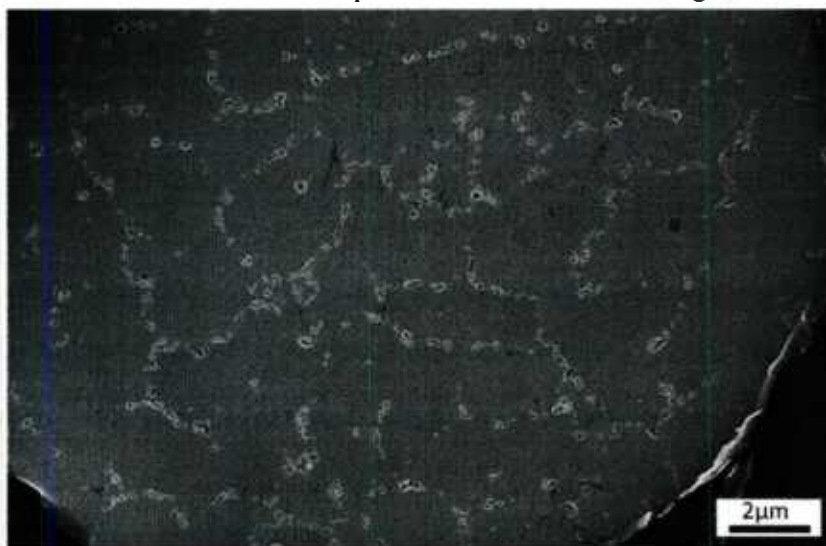
Figure 84. The sensitized 5083 powder had equiaxed grains as revealed with phosphoric acid etching.

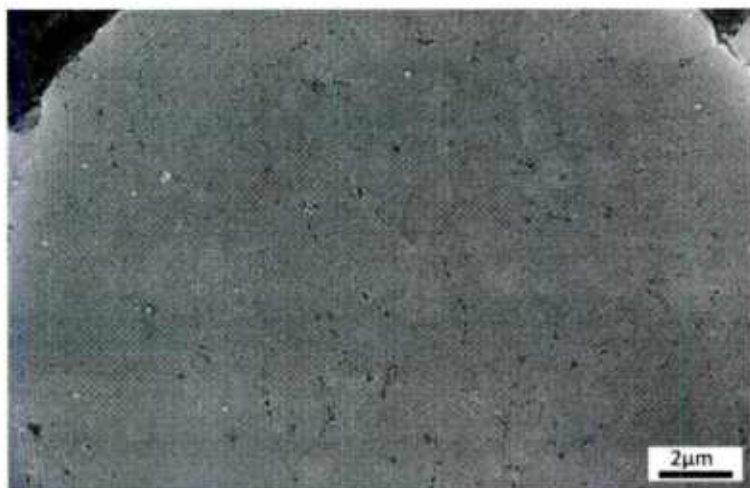
Figure 86. The as-received unsensitized powder also had equiaxed grains though not as distinct compared to the sensitized powder.
